EXISTING CONDITIONS PLAN OF KEDDY MILL  
ROUTE 202 WINDHAM, MAINE

FOUNDATION ASSESSMENT AND SEISMIC REVIEW  
KEDDY MILL, SOUTH WINDHAM, ME  
RESURGENCE ENGINEERING PROJECT NUMBER 08-027

FINAL REPORT  
FEBRUARY 11, 2009

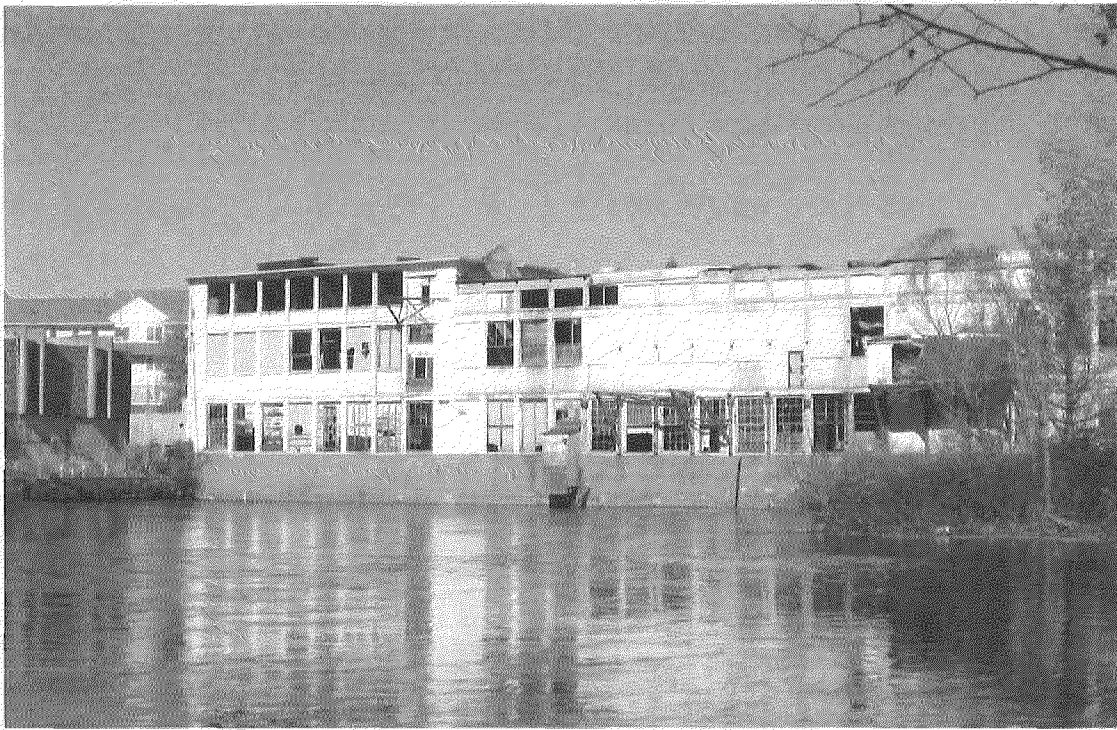
**PHOTO**  
**#1.1**

Keddy Mill: View from the south, looking at South Wall. West side Building is taller portion at left. Note water elevation to bottom of grade beam.

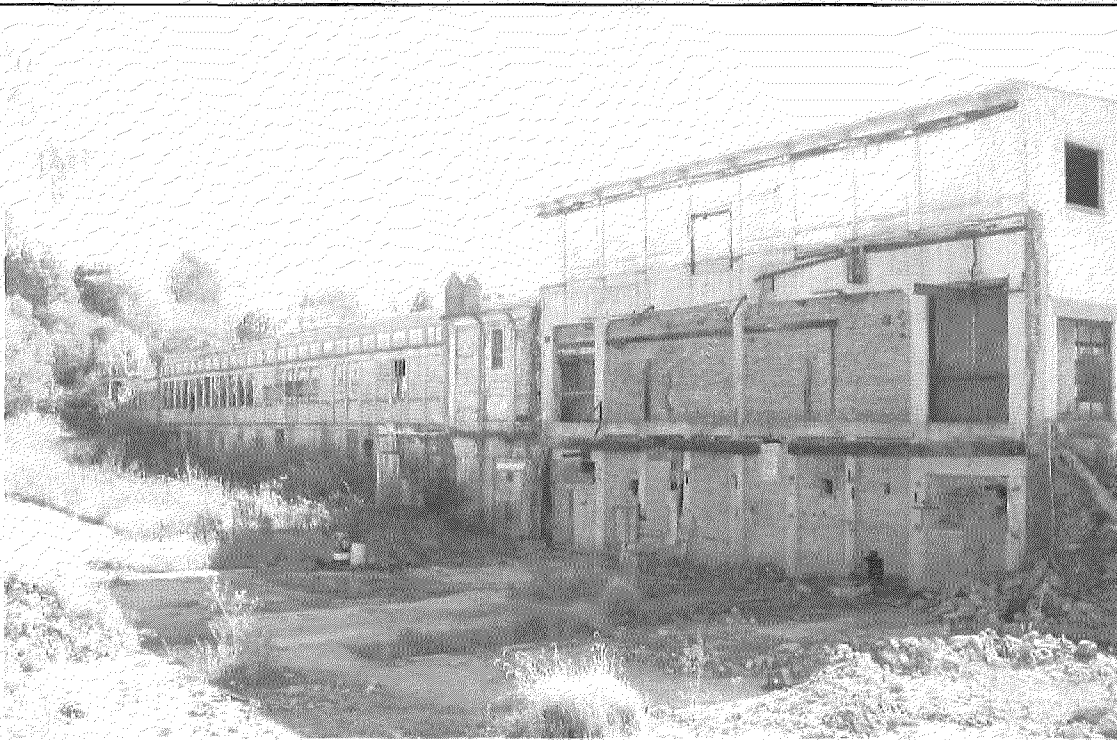
**PHOTO**  
**#1.2**

Keddy Mill: View from northwest. West side building (three story) is at right. Note that water flows downslope from the left of the photo and pours into the building near a vehicle door at left side of West building.

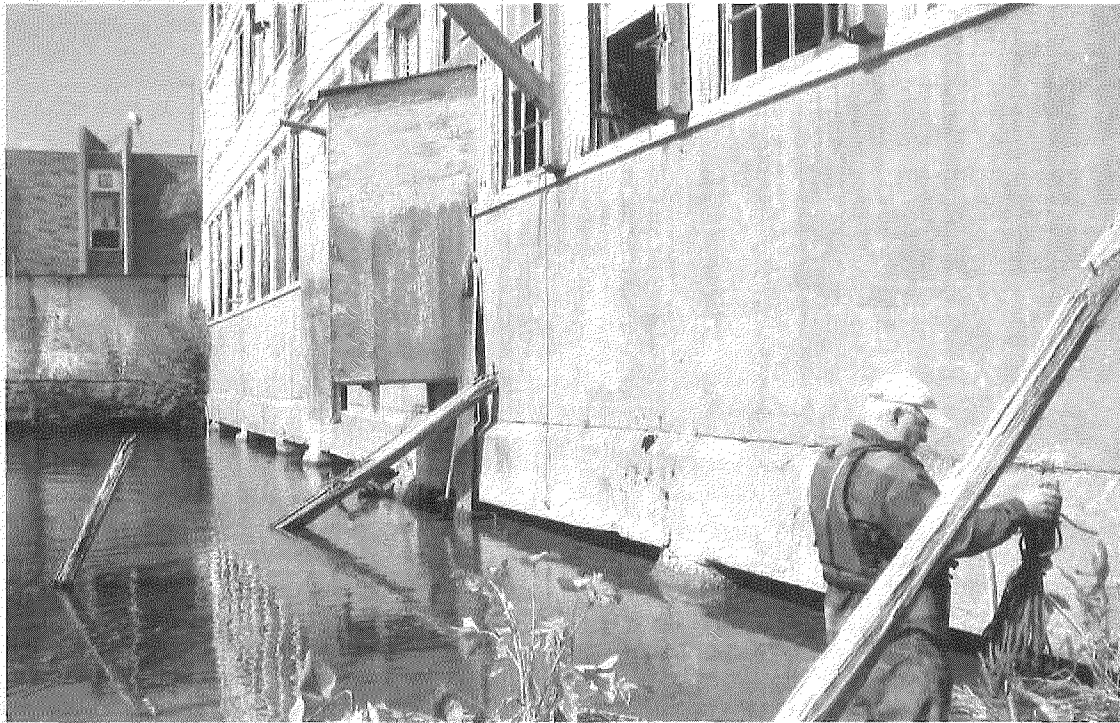
**PHOTO  
#1.3**

South Elevation, looking West: Piers visible above waterline at 24 foot spacing. During this visit, water depth was 12 inches below bottom of grade beam.

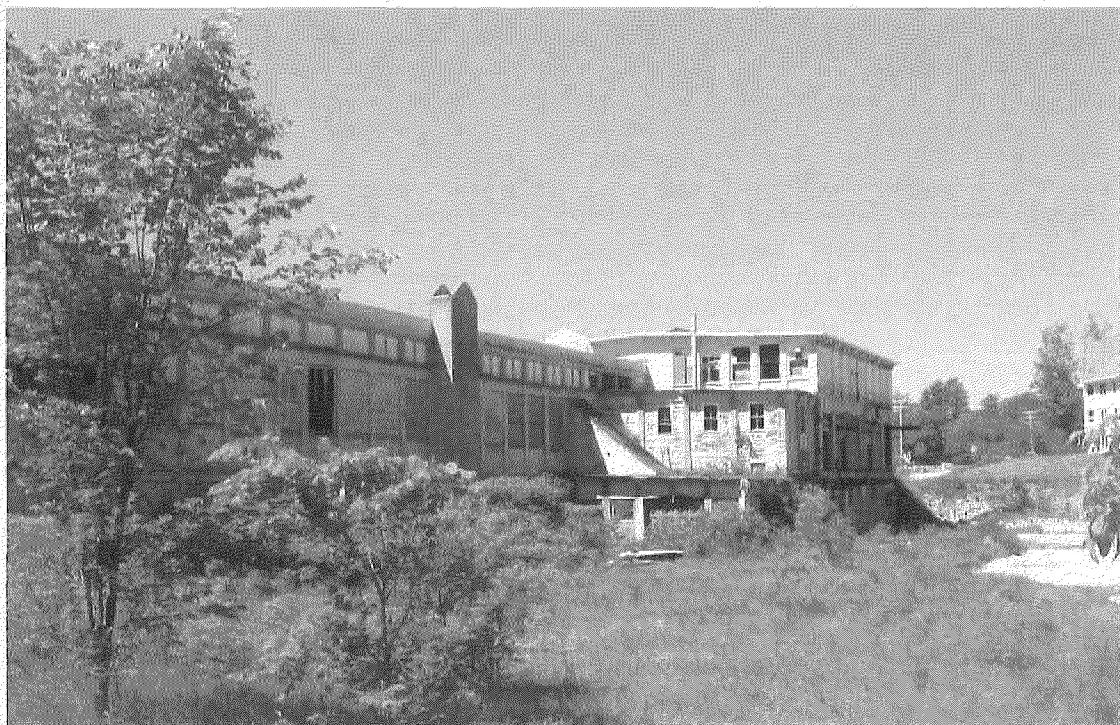
**PHOTO  
#1.4**

North Elevation, looking West: Large area of fill brought in at this side of the building.

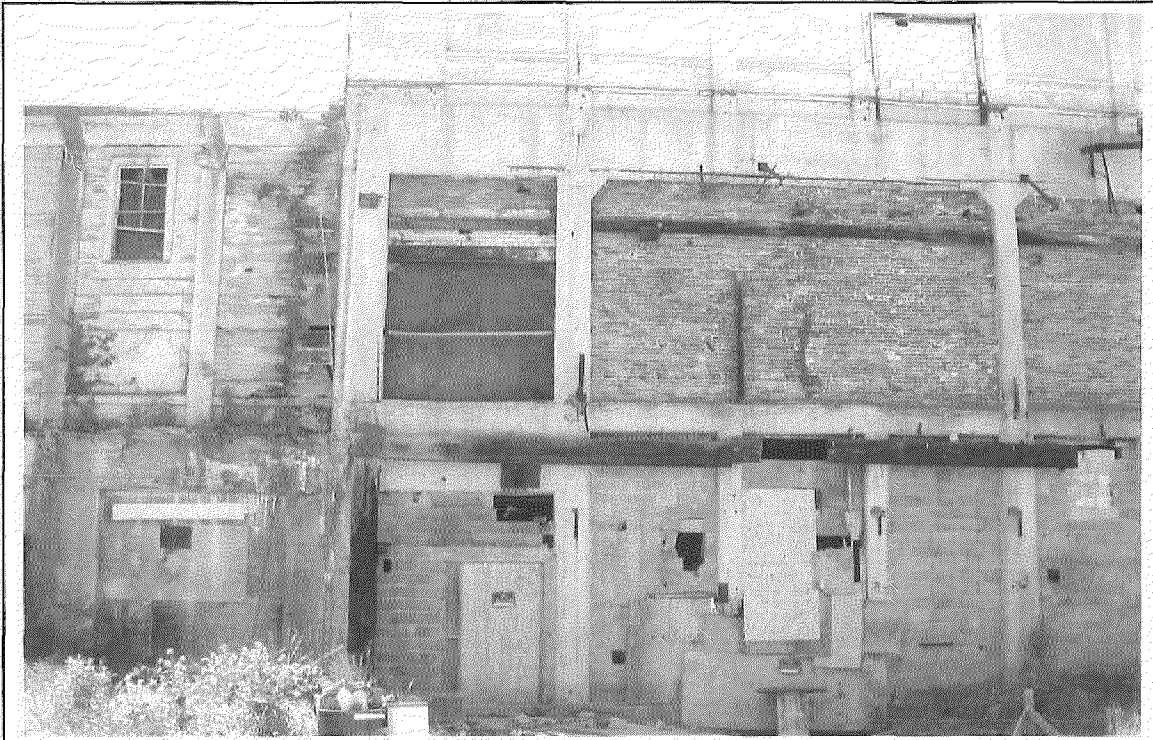
**PHOTO  
#1.5**

North Wall Detail at West Side Building: Plywood Sheathing indicates area of vehicular entrance. See photo below for runoff draining into building.

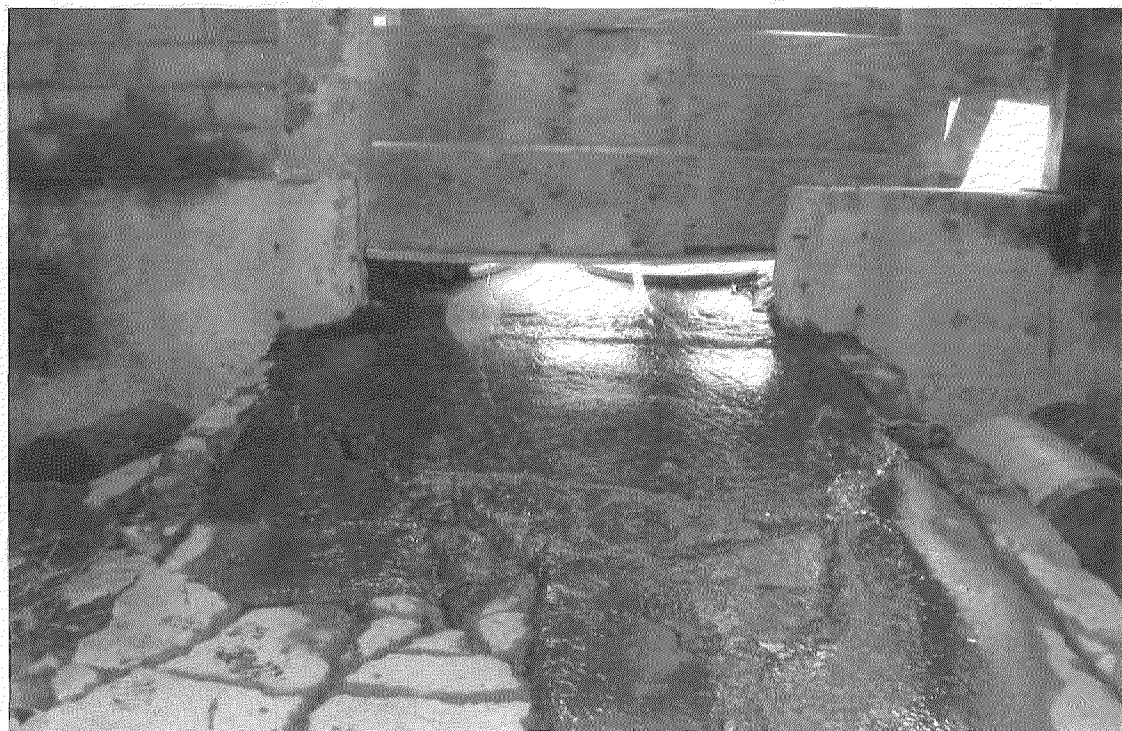
**PHOTO  
#1.6**

Detail at West Building, North Wall: Runoff draining into building from site. Water is running down a cast-in-place concrete vehicular ramp entering the building.

The site slope to the north of the building drops a significant quantity of rainwater along and into the building (Photo #1.6). Currently, this runoff drains through holes in the lower level slab and into the Presumpscot River. Site regrading and catch basins will be needed to control runoff. Because the final plan for the site is currently unknown, we will not consider these costs as they relate to the building foundation.

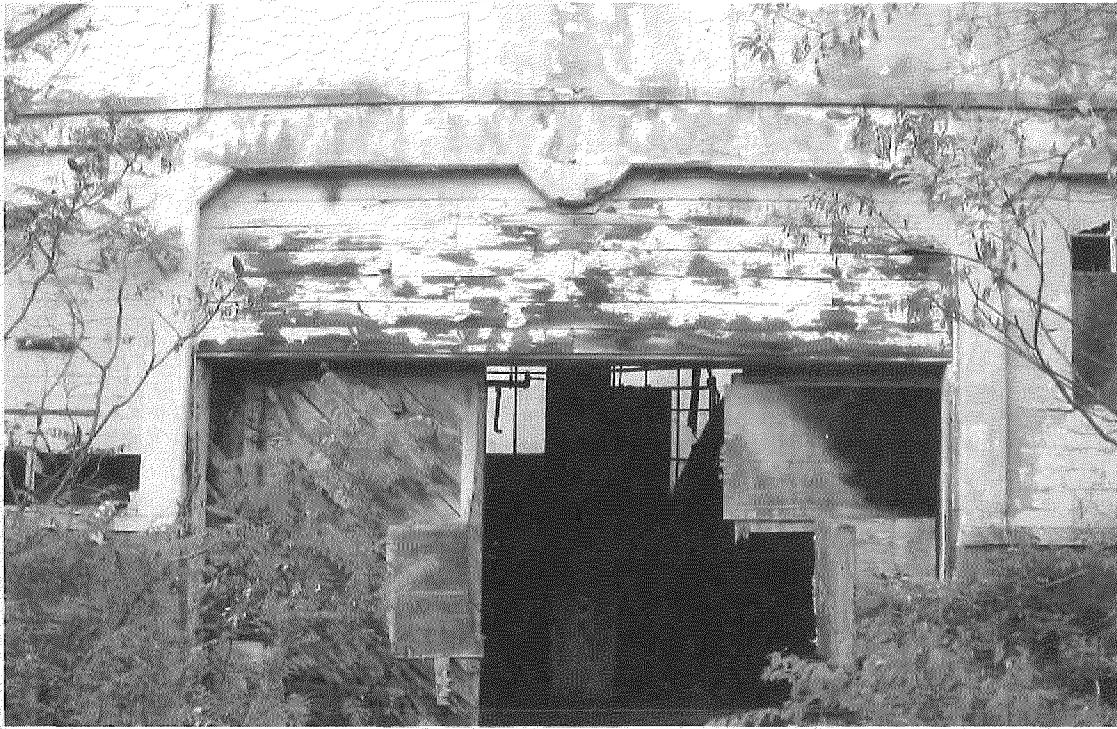
**PHOTO**  
**#1.7**

South Wall, East End: Vehicle Entrance. Note that ledge is very close to ground surface and slab at this end of structure.

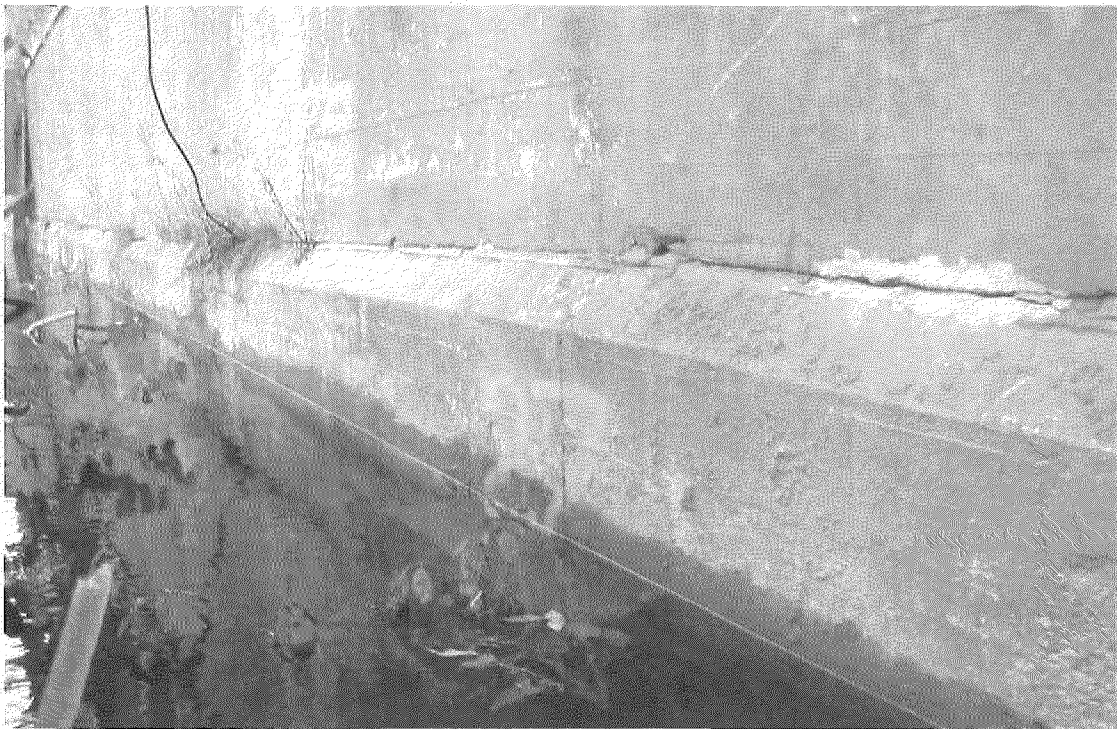
**PHOTO**  
**#1.8**

Detail: Groundwater height fluctuation at South Wall, Grid Line 27. Note that water elevation in this photo is approximately 2 feet higher than in previous site visit one week earlier.

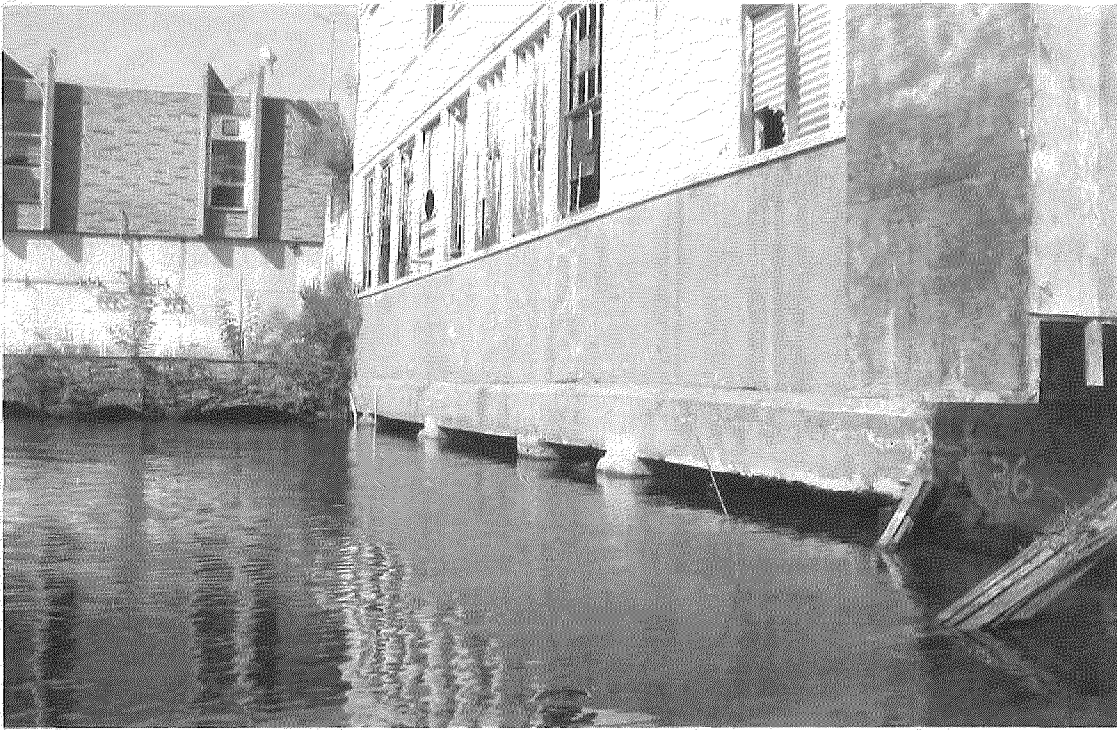
**PHOTO**  
**#2.1**

Keddy Mill, South Wall: Piers, Grade Beams, and Foundation Wall along South Wall, from Grid line 36 to grid line 47. Water depth limited access only to line 40.

The visible grade beams along the south building wall measured approximately 3'-0" high x 4'-0" wide. We observed structural distress at lines 40, 39, 36, and 33 (Photos 2.1, 2.2, 2.5, 2.8). In places, it appears that large steel beams or plates are encased in the concrete grade beam over the water (Photo #2.6). It is unclear whether these beams were used as primary reinforcement, or whether or not they were encased after being used to construct the extensive formwork needed to build the elevated slab.

- 4.3.1 Repair south wall grade beam (approximately 167 lineal feet of exposed beam) over water. Due to access, repair prices will be high for this work. 167 feet x 3 feet x \$100 per square foot = \$50,000.
- 4.3.2 Install two new 40-ton piles at each of four locations along the south wall, at column lines 40, 39, 36, and 33. Consider two 30-foot long piles at each location with associated concrete removal and repair costs. Each Location: 60 lf piles at \$60/lf plus \$2,000 demolition + \$1,900 concrete repairs and patching per location x 4 locations = \$30,000

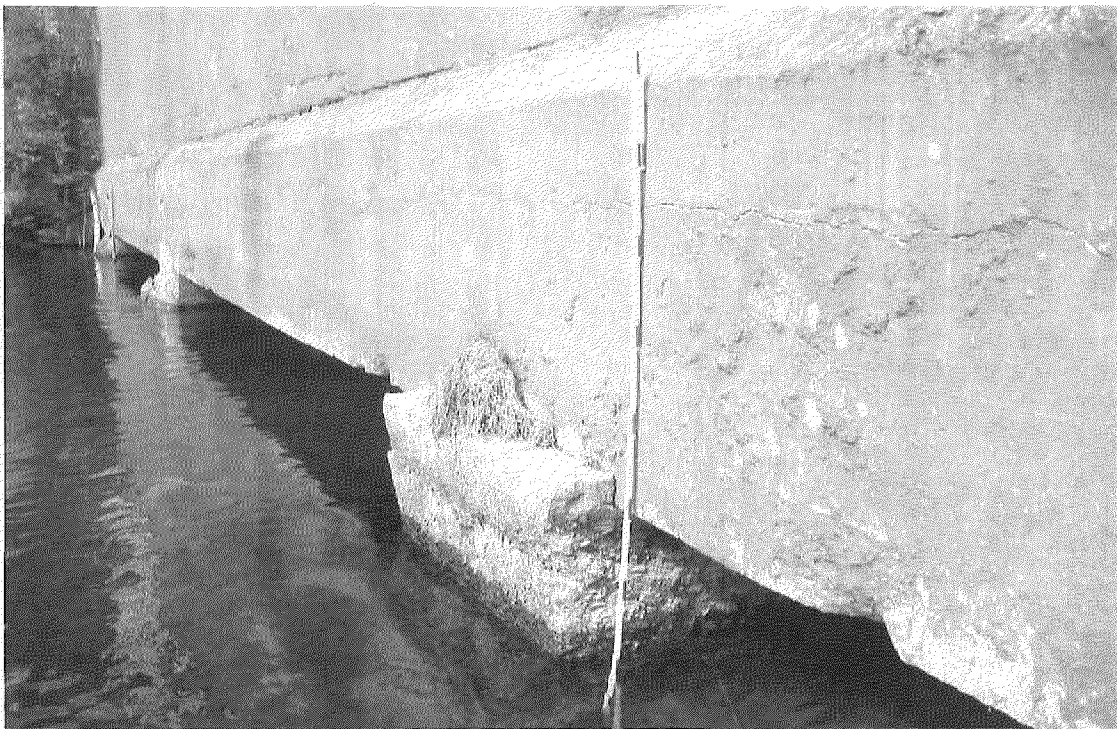
**PHOTO**  
**#2.2**

Detail: South Wall Pier at Line 40: Note horizontal grade beam crack. Pier is surrounded by a rotten wooden cofferdam visible in the water to the left of the pier. 12" clearance, water to bottom of grade beam.

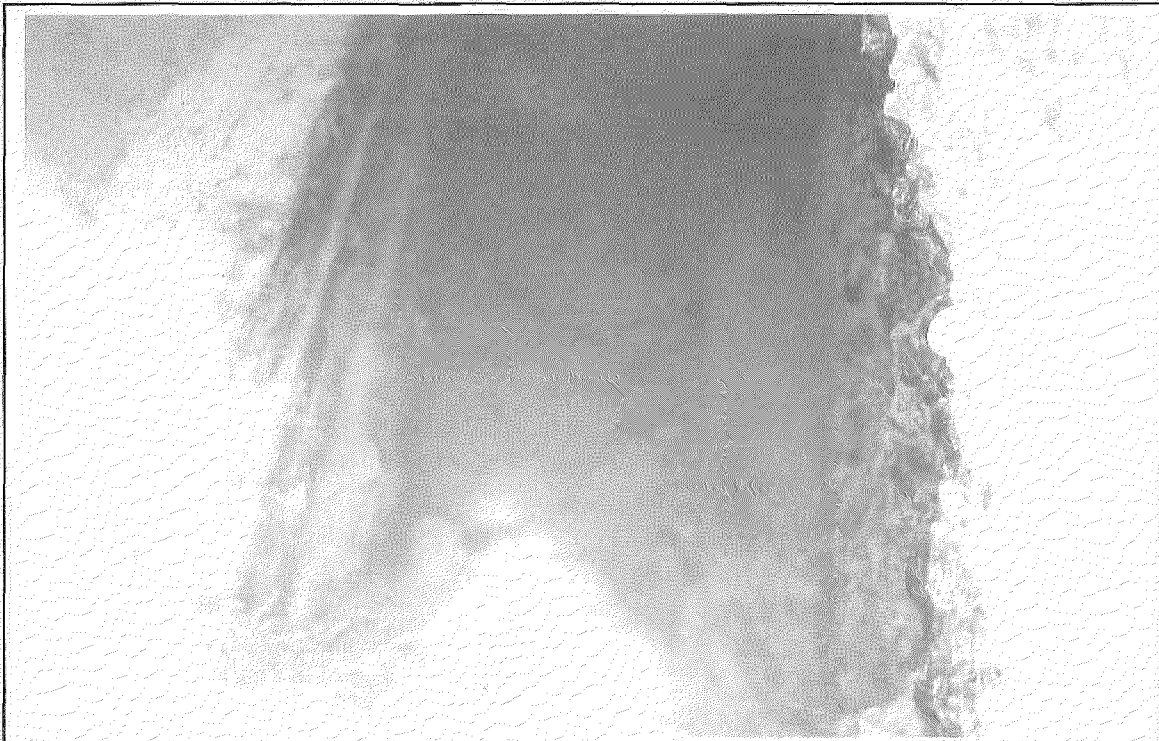
**PHOTO  
#2.3**

South Wall Pier, Line 40: Cofferdam at left, possible original formwork 2'-3" below water surface at right (arrow) may indicate bottom of Pier.

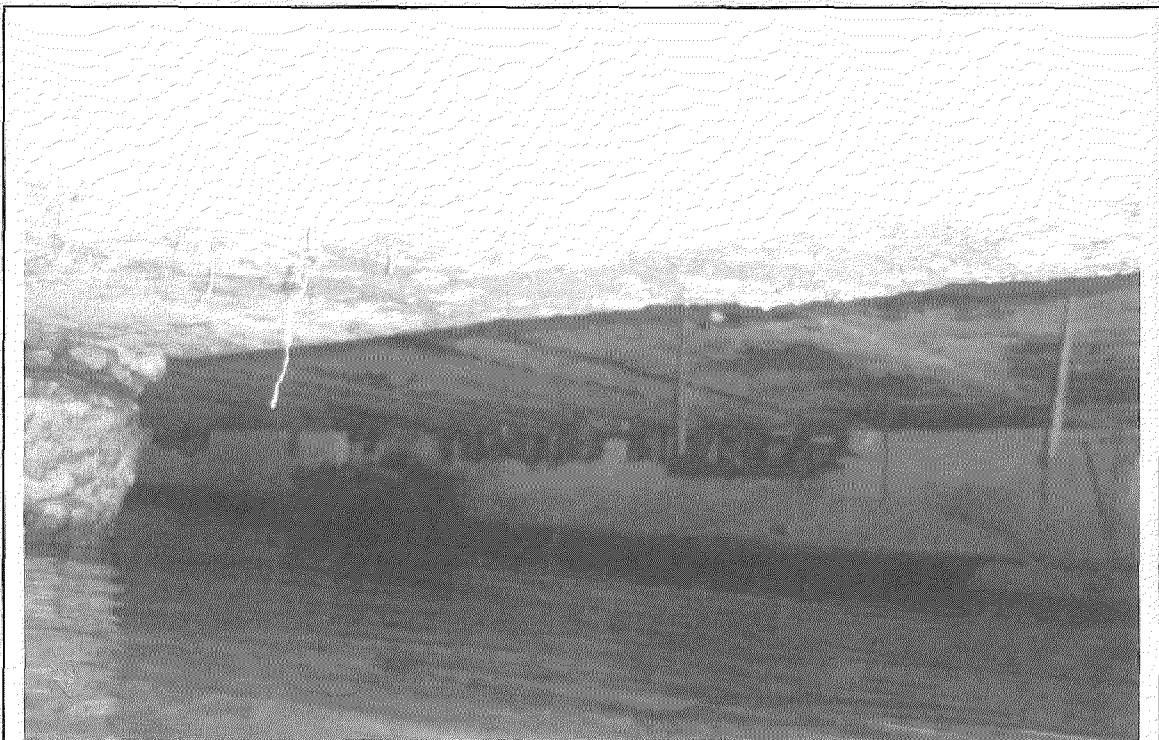
**PHOTO  
#2.4**

South Wall, looking North: View of elevated slab underside. Pier 40 at left. Note flat slab to Pier 40, then slab-beam system from Column line 40 west to Column line 47.

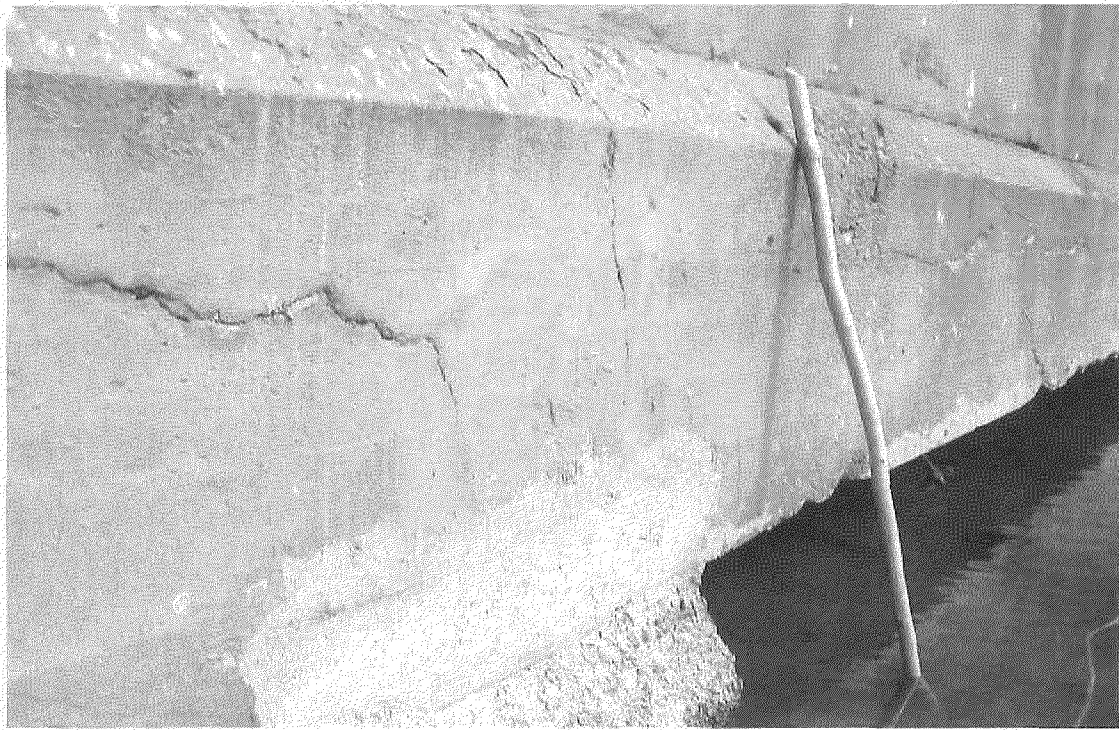
**PHOTO**  
**#2.5**

South Wall Grade Beam at Pier 39: Note cracking at left of photo, and crack beyond wading stick at right.

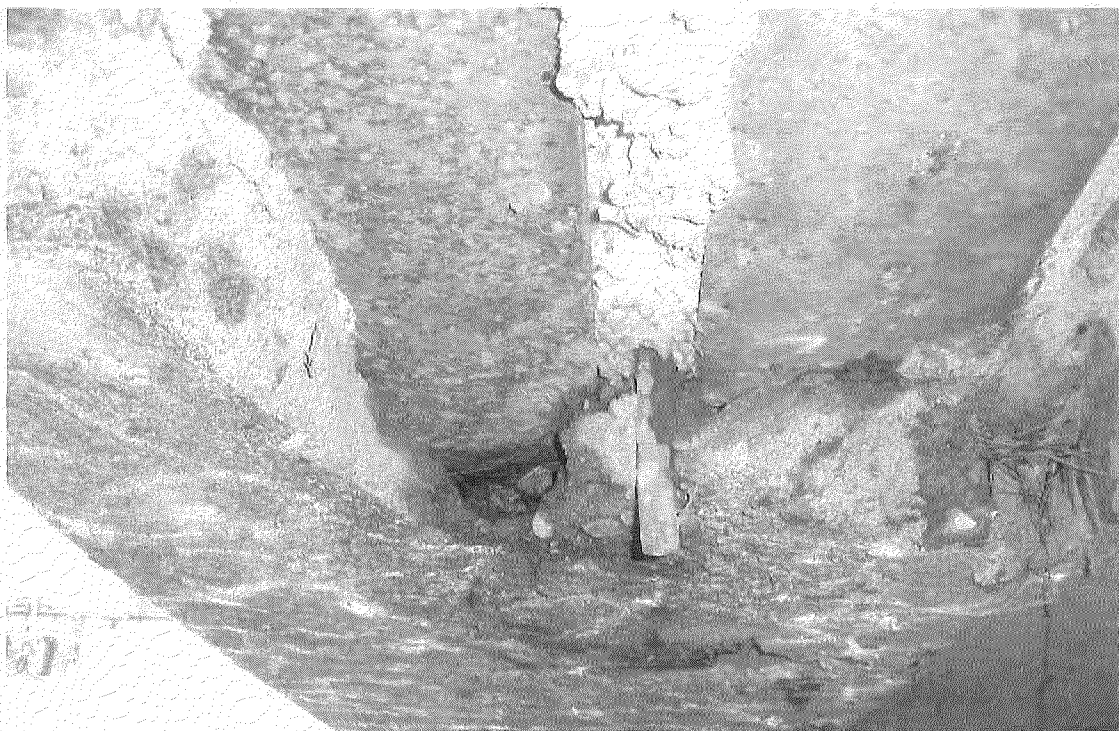
**PHOTO**  
**#2.6**

South Wall Underside of Grade Beam, Looking from Line 36 to 39: Spalled concrete reveals structural steel plates, possibly the underside of wide-flange beams encased in concrete. Repair necessary. Cathodic protection possible.

River. The bottom face of this grade beam has experienced spalling and corrosion. Repairs and future corrosion protection perhaps supplemented by impressed current cathodic protection, will be required.

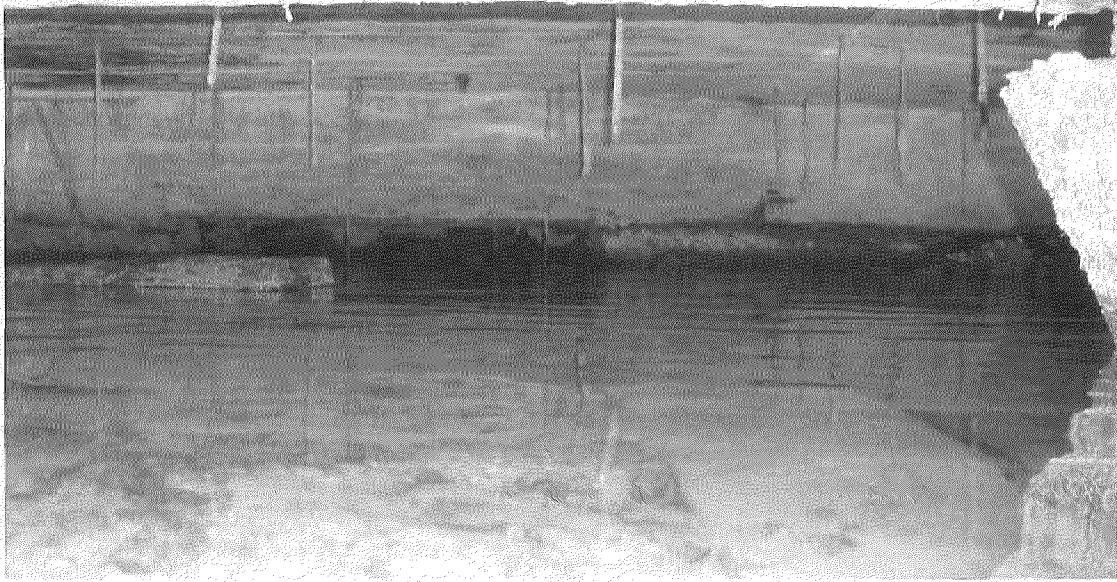
**PHOTO**  
**#2.7**

South Wall: Slab Underside at Line 39: Note flat slab supported by grade beam and pier along interior line of framing.

We were unable to measure the interior grade beams due to the amount of water at the time of the inspections (Photo #2.7, Photo #3.7). What we were able to see of the interior beams were in good condition, and likely need little work.

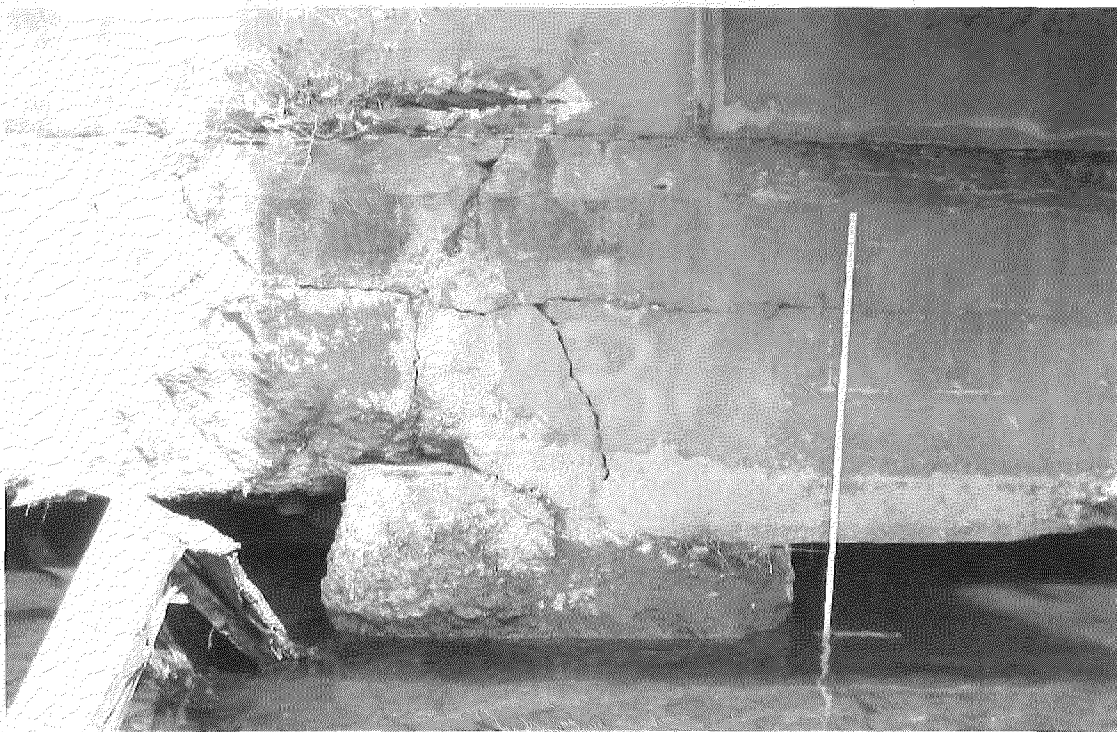
**PHOTO**  
**#2.8**

South Wall Pier at Line 36: Note Cracking and Spalling of Concrete. Piece of bent metal at left partially obstructs view of grade beam. Repair required.

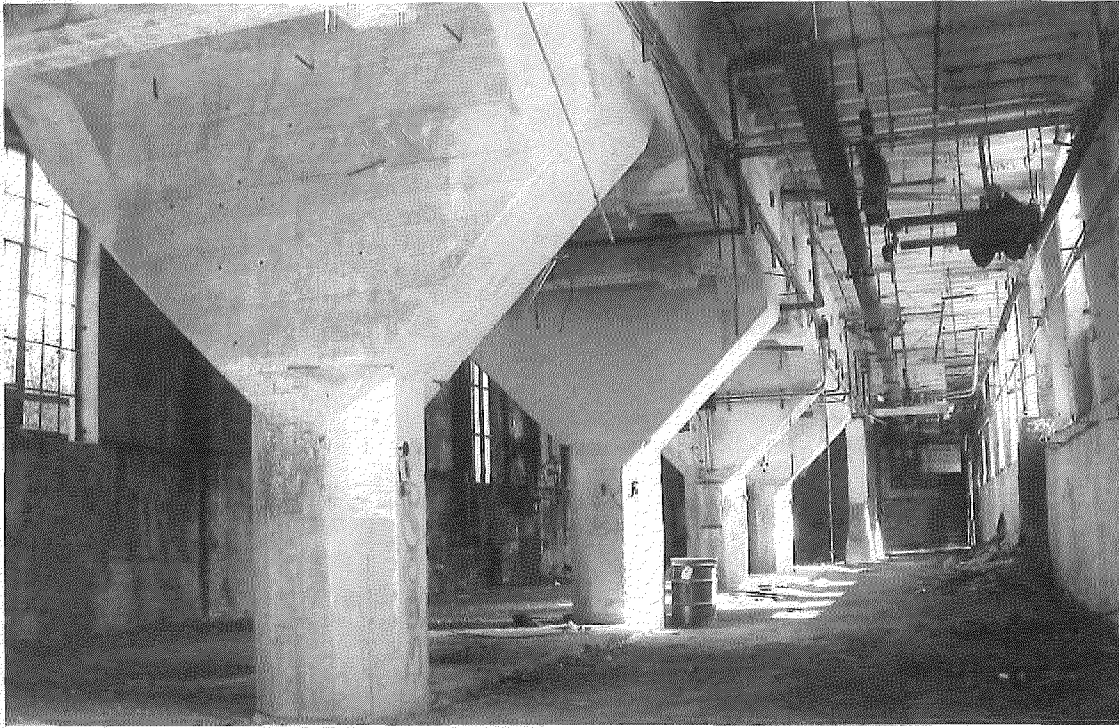
**PHOTO**  
**#3.1**

**Keddy Mill, Basement:** Proposed Parking Area. Note South Foundation Wall at Right. Columns on top of foundation wall can be braced across to center beam above triangular pier.

The amount of debris along the south wall of the building, along with the silt accumulated at the west building prohibited complete assessment of existing floor slabs (Photo #3.1 and #3.2). A combination of concrete slabs on grade (assumed at the eastern half of the building) minimally-reinforced flat structural slabs (center of the building), and a structural beam and slab system (observed at the western side of the building) support the lower level floors. Soil borings indicate that the slabs were placed upon loose fill brought in to bring the floor height up to the desired level. A structural beam and slab system is built over the Presumpscot River. These three very different floor types behave differently and are subject to varying forces.

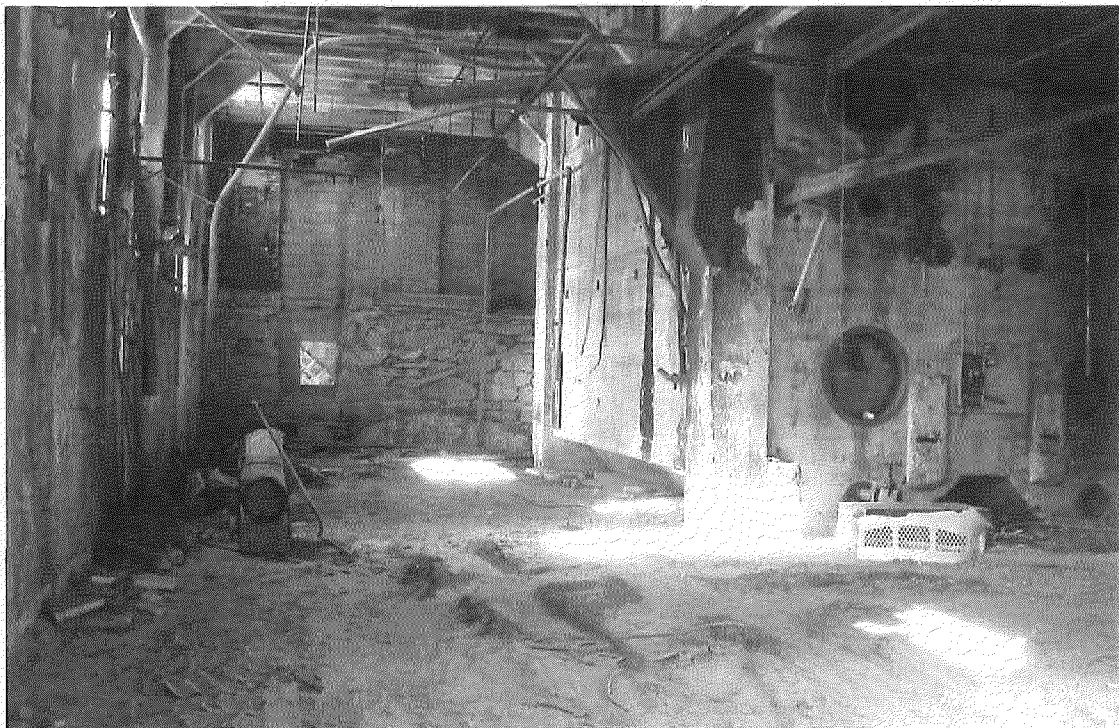
**PHOTO**  
**#3.2**

**Detail: Looking Toward West Retaining Wall:** Rubble and brick are in poor condition, and should be stabilized. This wall should be supplemented and/or demolished and rebuilt. Also note thick silt deposits on elevated concrete slab

The westernmost retaining wall, closest to the dam, is in poor condition and will require substantial structural strengthening. It will be necessary to build a completely new wall inboard of the existing western wall, using a combination of lateral soil anchors, grade beams, and new piles to properly support it. The massive boiler structure may also prove useful as a means to brace this new inner wall. Keep in mind that the alternative that considers completely demolishing the mill still carries a significant cost associated with stabilizing the existing basement retaining wall. It is likely that that cost exceeds the \$250,000 cost included in this estimate because of additional disturbance to the neighboring power plant. As we discussed, that cost was earlier discussed as approaching \$450,000.00.

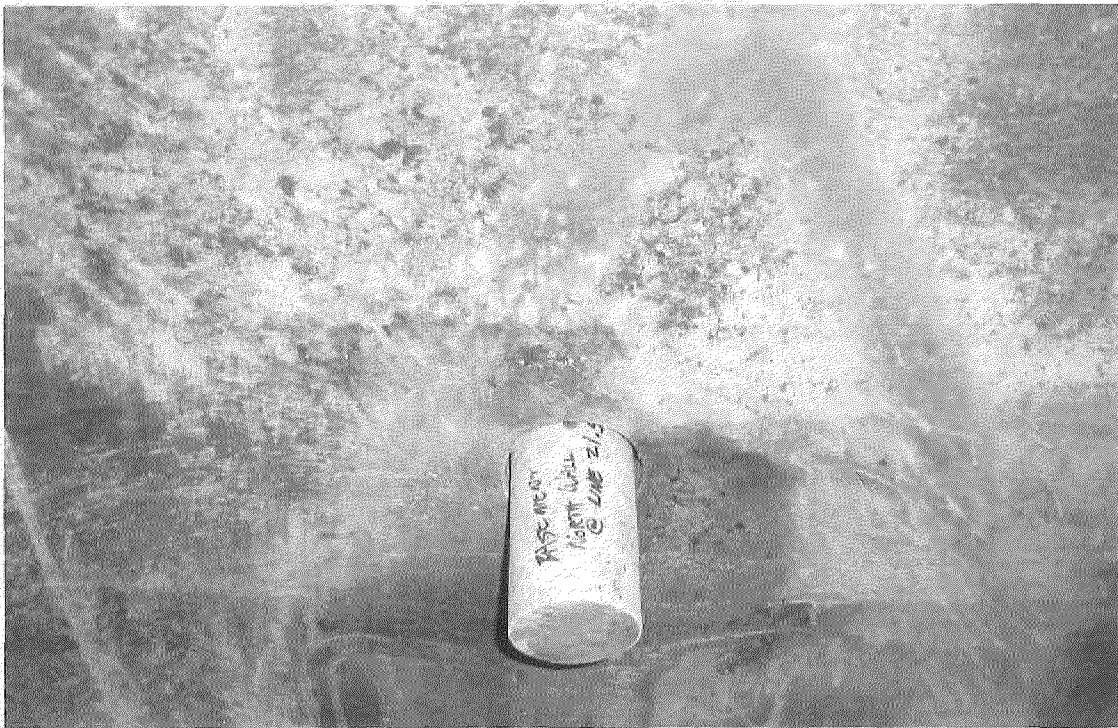
**PHOTO  
#3.3**

North Wall Core: Core taken from north wall for material evaluation. This concrete core had a compressive strength of 5138 psi.

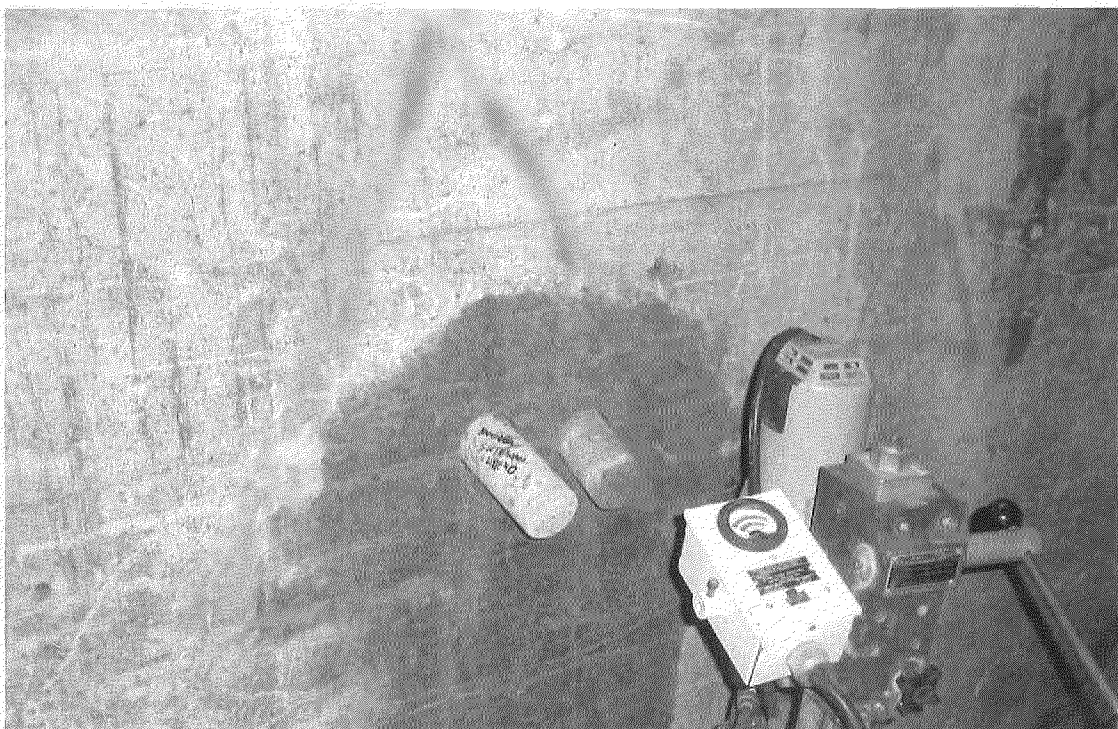
**PHOTO  
#3.4**

South Wall, Core at Line 40: Core taken at Line 40 for materials evaluation. Concrete core tested at 4026 psi.

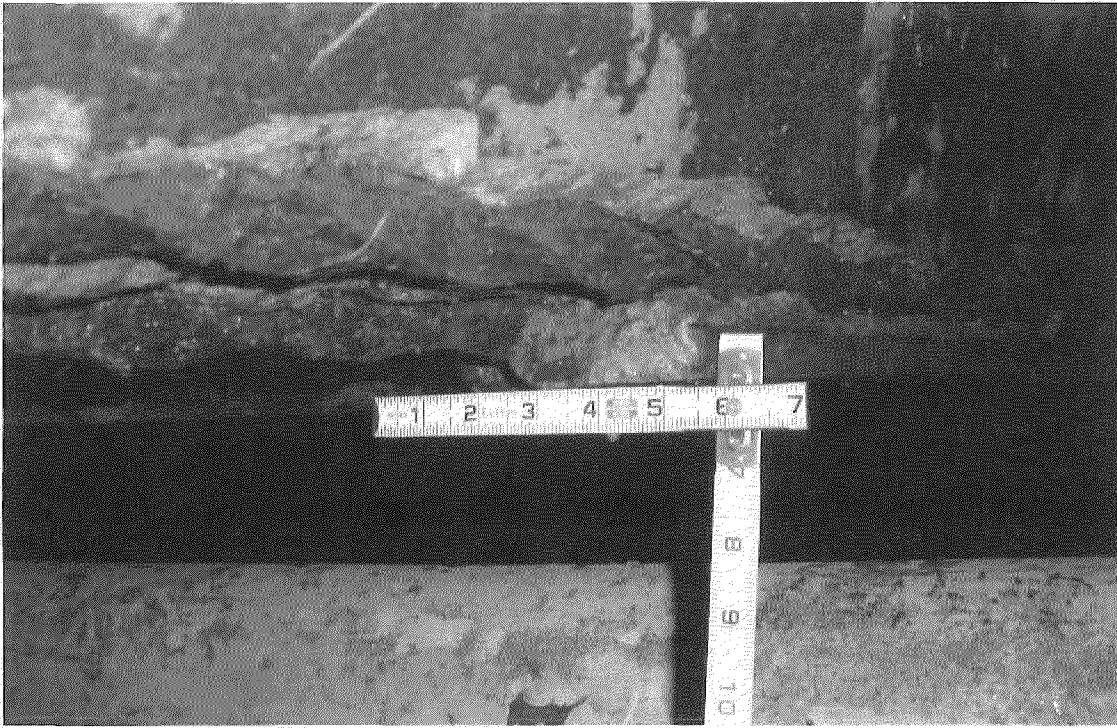
**PHOTO**  
**#3.5**

West side Building Concrete Beam below slab: Note spalled concrete and exposed steel "twisted square" rebar. Concrete repairs will be significant under this slab.

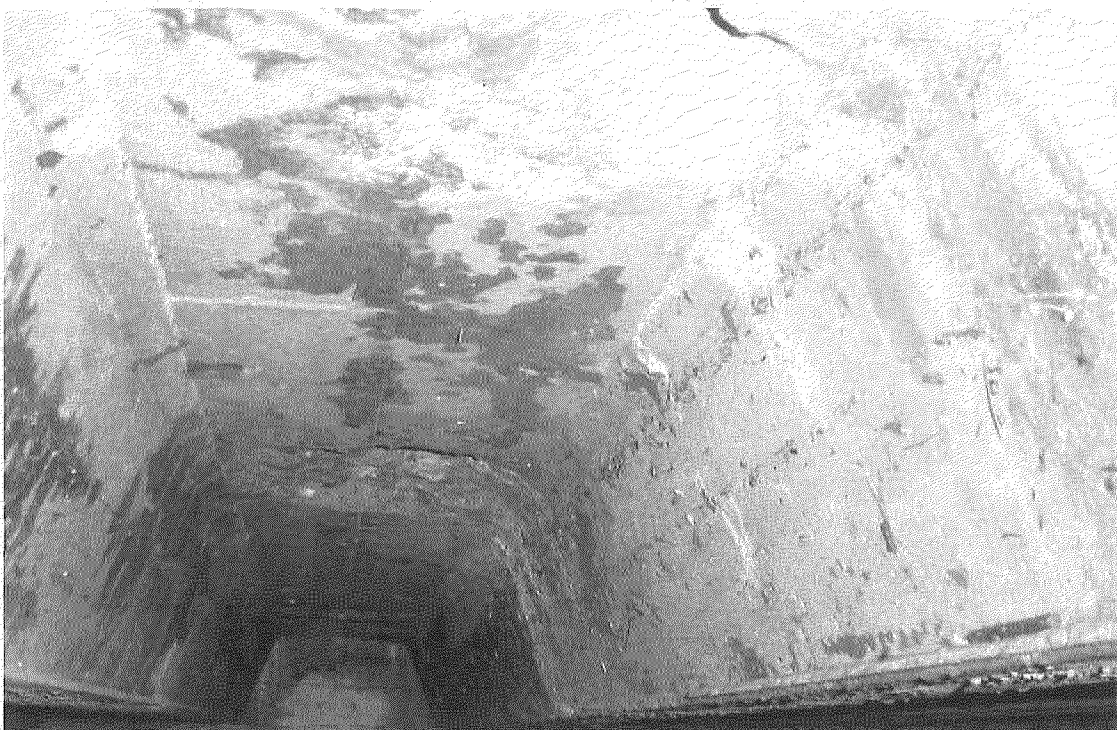
**PHOTO**  
**#3.6**

Underside of slab near Grid Line 43 and Grid Line B. Though not visible, small cracks exist along the length of many of the interior beams.

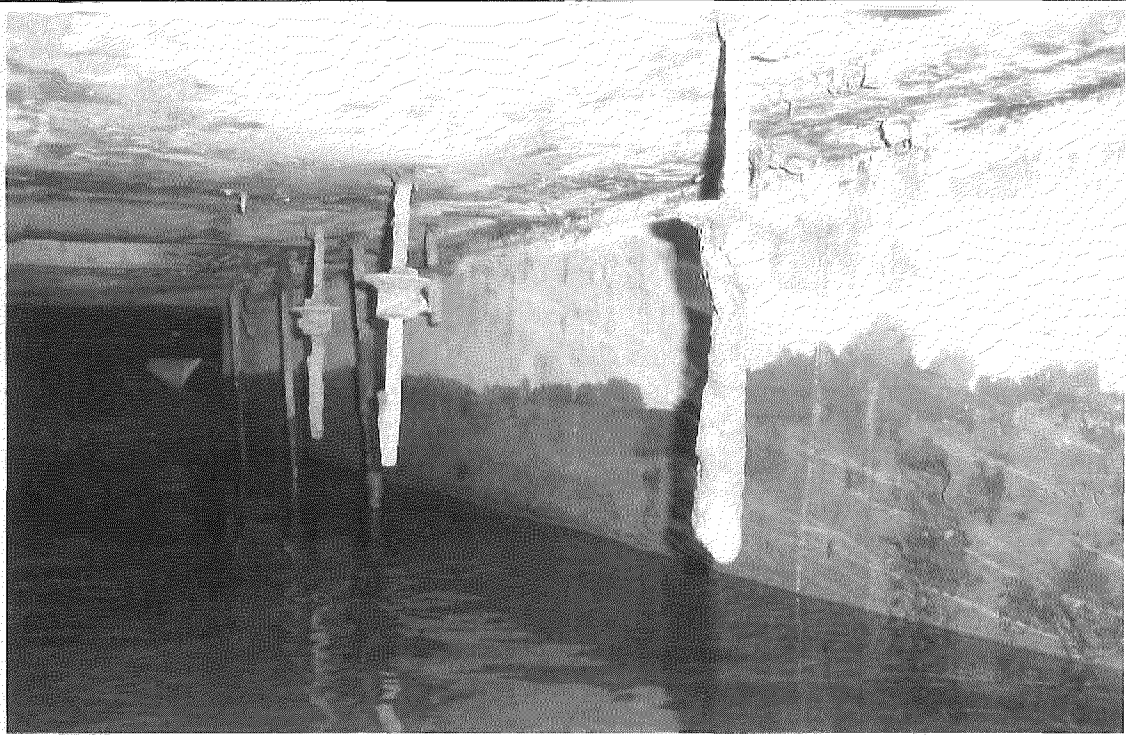
**PHOTO**  
**#3.7**

B-Line Grade Beam, Looking East toward Line 40: Hanging anchors that supported slab formwork are visible long after formwork was removed or rotted away; Grade Beam visible at right.

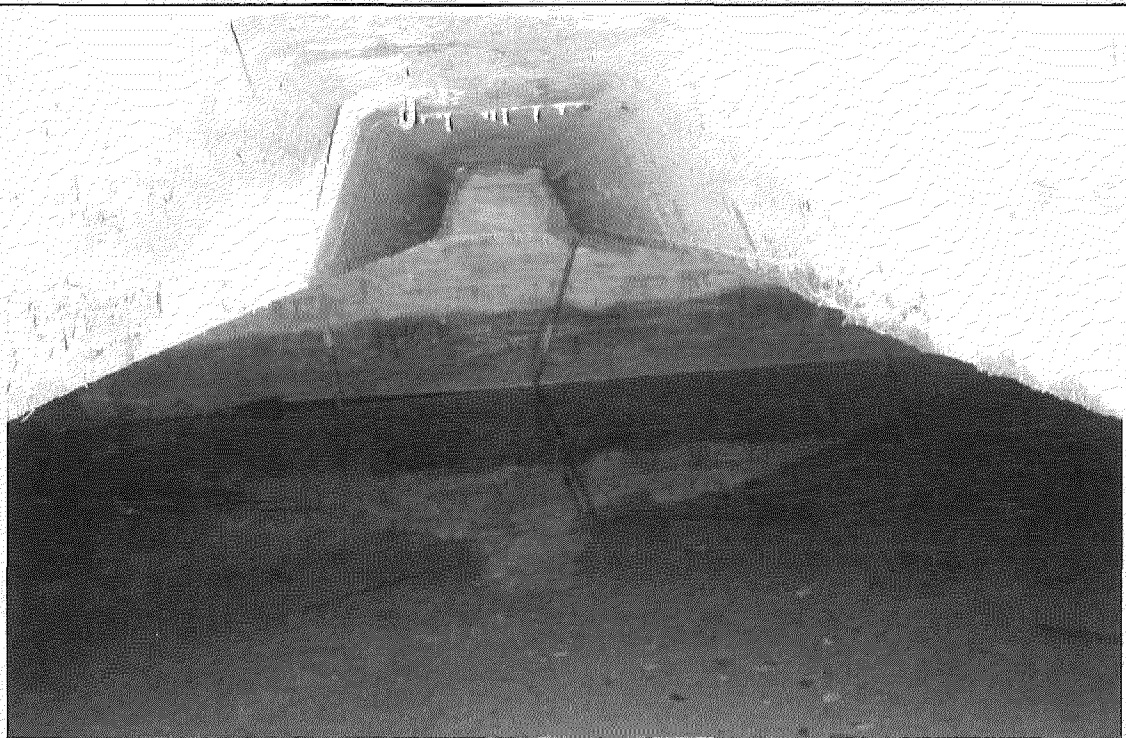
**PHOTO**  
**#3.8**

West End, Looking from Line D to Line C near Column Line 43: Note Shallower water depth, this area.

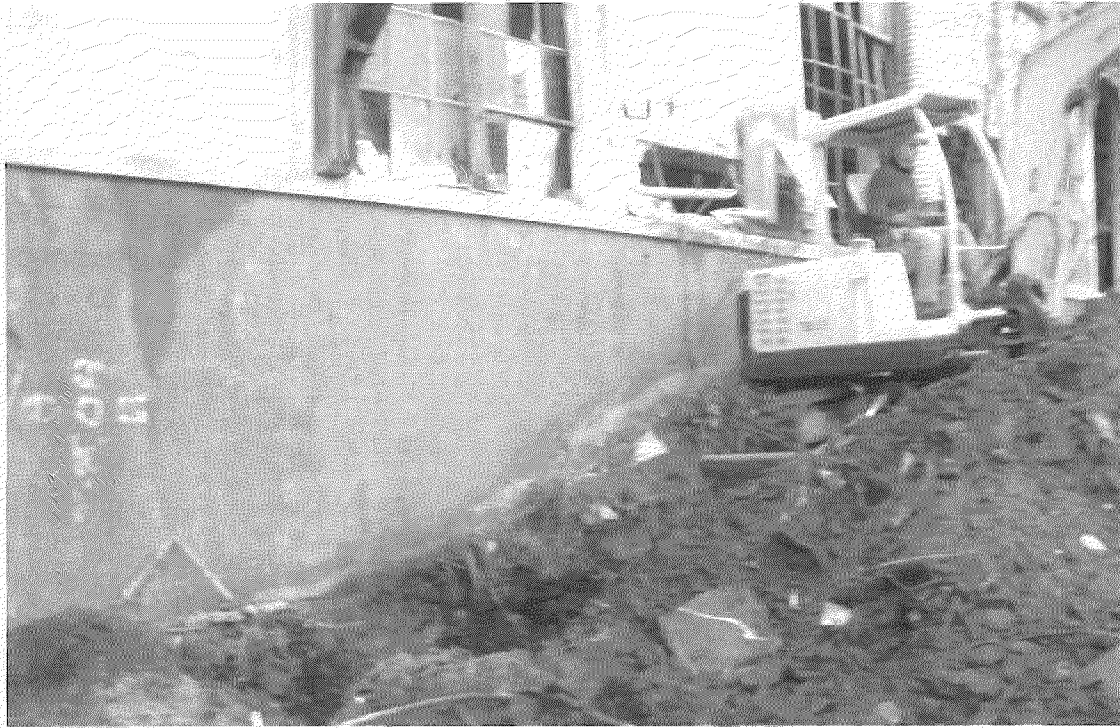
**PHOTO**  
**#4.1**

Keddy Mill: South Wall Excavation at Pier 24.

Summit excavated a south wall "pilecap" at column line 24, to determine the size and number of piles supporting it. The excavation extended to a depth of five feet along the face of the "pilecap" without reaching its bottom (See Photos 4.1 through 4.6). Importantly, we also observed spiked-together lumber cribbing surrounding at least three sides of the "pilecap". Knowing that the depth from top of "pilecap" to ledge at this location is approximately 18 feet, we now believe that the building is constructed on square piers that extend down to ledge, instead of on timber piles. We believe this because the pier size (3'-6" x 4'-0") would not have been large enough to permit installation of a sufficient amount of timber piles to carry the heavy dead loads (nearly 200 kips) anticipated on the pile group, let alone heavy floor loads imposed by the industrial use.
